NACA RM E54K23

AN EXPERIMENTAL EVALUATION OF SEVERAL DESIGN
VARIATIONS OF HOLLOW TURBINE BLADES FOR
EXPENDABLE ENGINE APPLICATION

By W. C. Morgan and R. H. Kemp

February 23, 1955

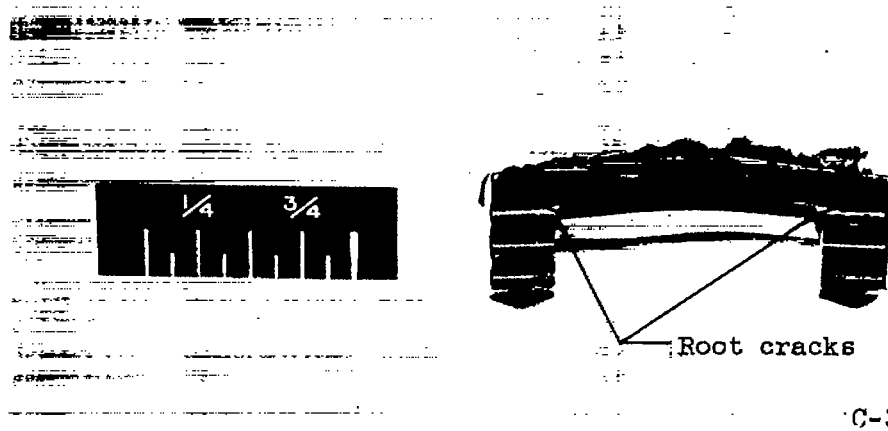
Group 1. - (L-605, 0.030-in. wall, all-welded, fig. 3, base D.) All of the six specimen blades failed in less than 10 hours. The immediate cause of failure was deformation in the base. Figure 9 shows the type of failure. It was noted also that the weld penetration was not uniform

in the base attachment. The results indicated that this type of base is of insufficient strength and that the relative disparity in mass between the airfoil and the base is unfavorable for welding.

Figure 9. - Failure of Group 1 sheet-metal blade showing the excessive base deformation and location of root cracks.

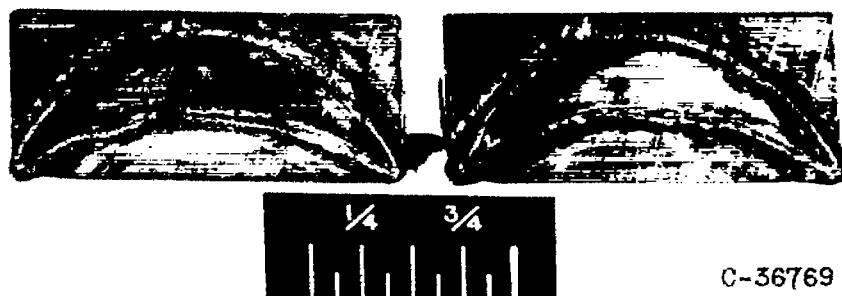
Group 2. - (L-605, 0.030-in. wall, all welded, fig. 3, base C.) In this group of blades the importance of sound welding was exemplified. All six blades failed because of imperfect weld penetration; four blades failed in less than five hours. Figure 10 shows typical failed specimens. Automatic machine weld might prove to be more effective in making joints of this type.

Figure 10. - Two failures of Group 2 sheet-metal blades showing the imperfect weld penetration.

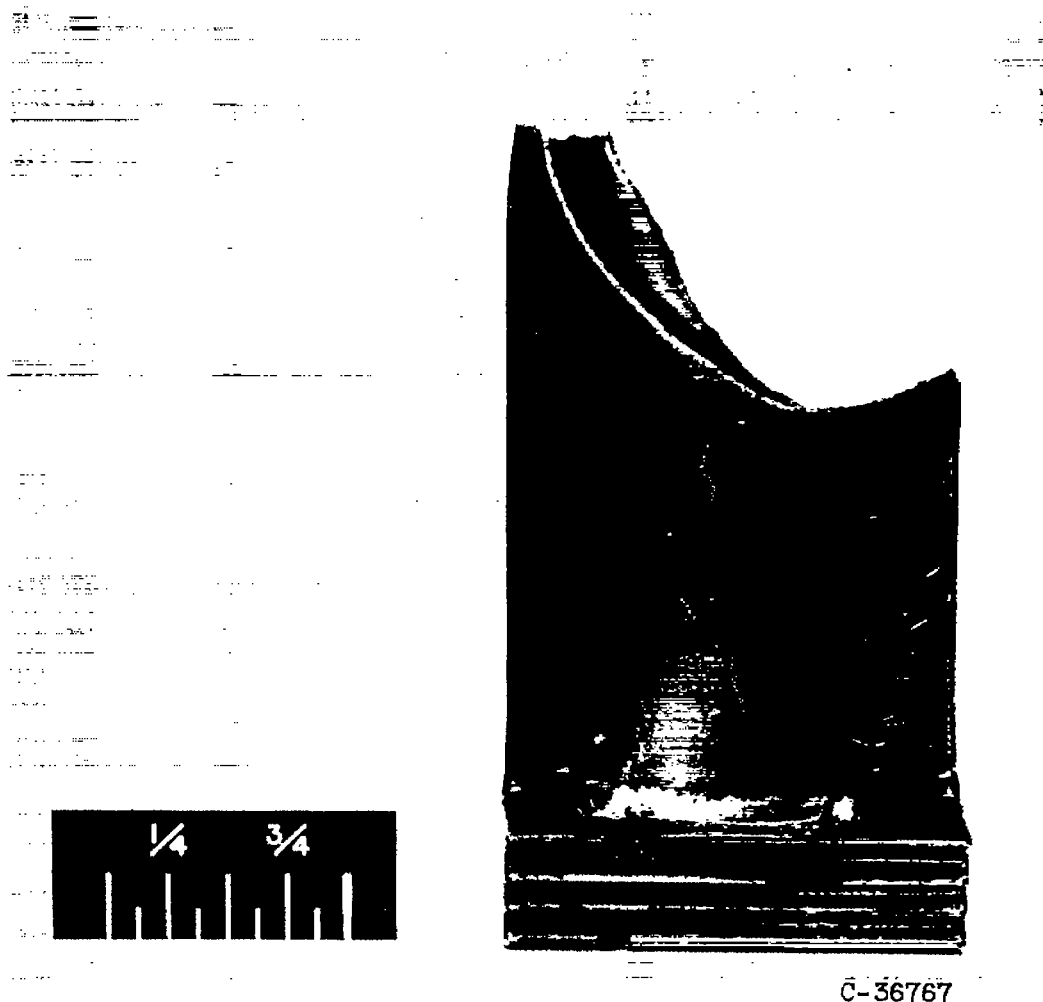
Group 5. - (L-605, 0.025-in. wall, welded airfoil brazed to stub, fig. 3, base A.) One blade failed as a result of excessive clearance in the brazed attachment. Three blades were removed from testing because of failure in the airfoil at the midsection. Two blades were still intact after 30 hours of operation. The failures appeared to be the result of fatigue. Figure 13 shows a representative failure in the airfoil midsection.

Figure 13. - Mid-section airfoil failure in Group 5 sheet-metal blade suspected to have been caused by fatigue.

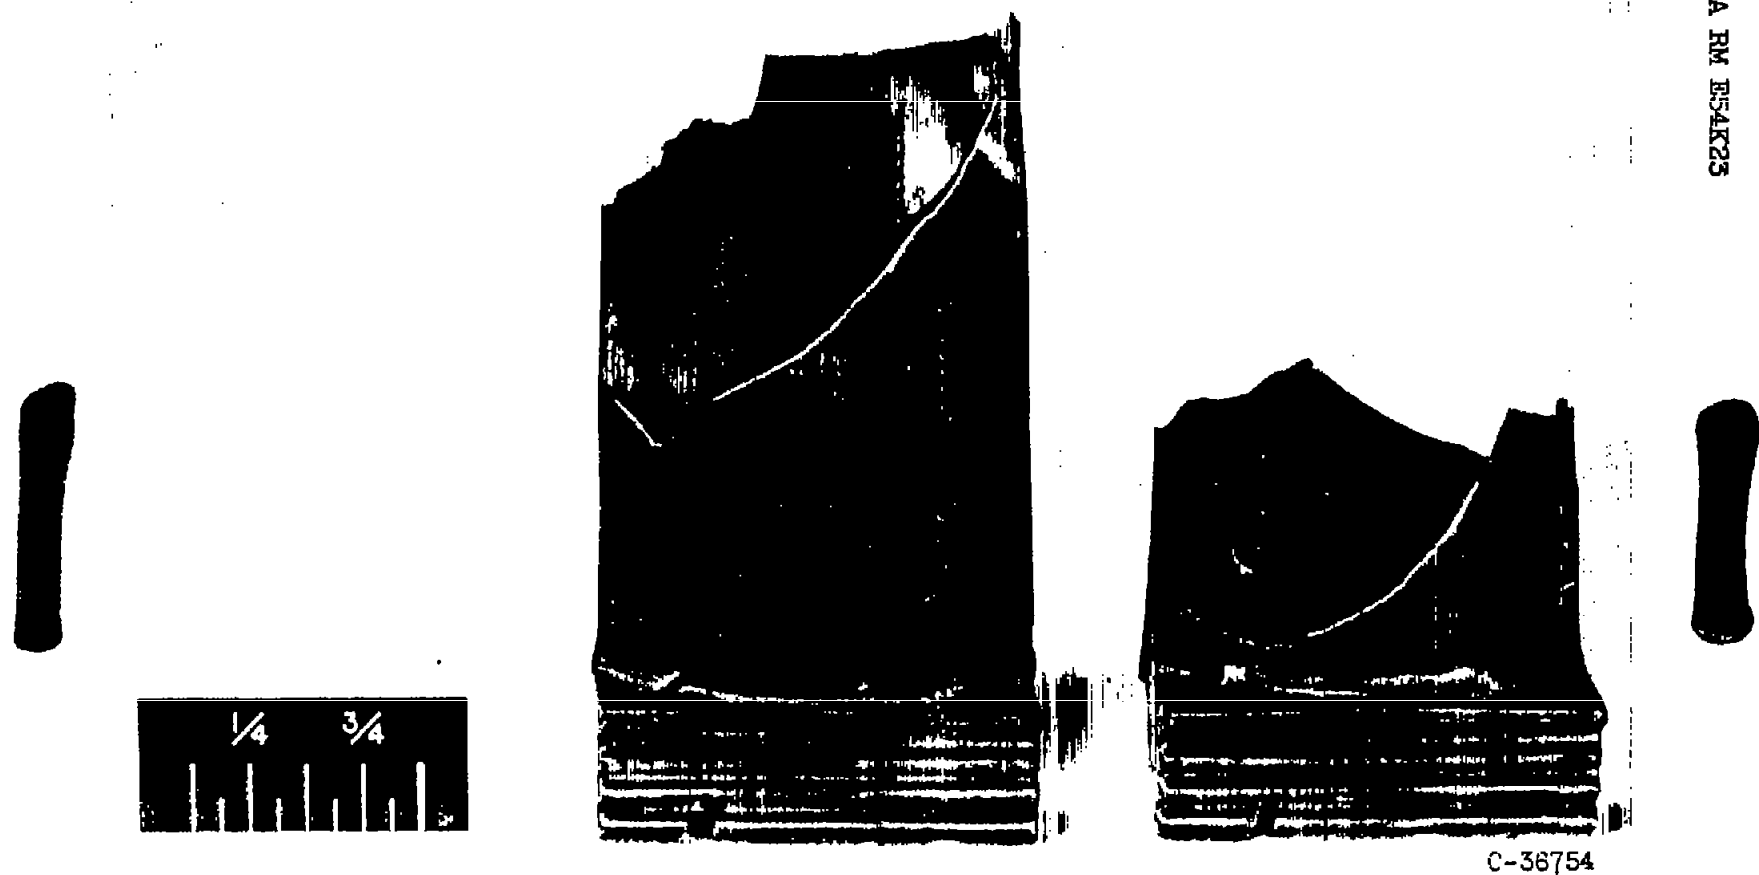
Group 6. - (L-605, 0.022-in. wall, welded airfoil brazed to stub, fig. 3, base A.) Failure occurred in less than 10 hours of operation for the six blades of this group. Serious cracking or actual rupture in the airfoils occurred near the base, the midsection, and the tip. Figure 14 presents typical failures. It is probable that the decrease in structural rigidity caused by the relatively thin airfoil wall made this type of blade particularly susceptible to vibration.

Figure 14. - Typical failures of Group 6 sheet-metal blades suspected to have been caused by fatigue.

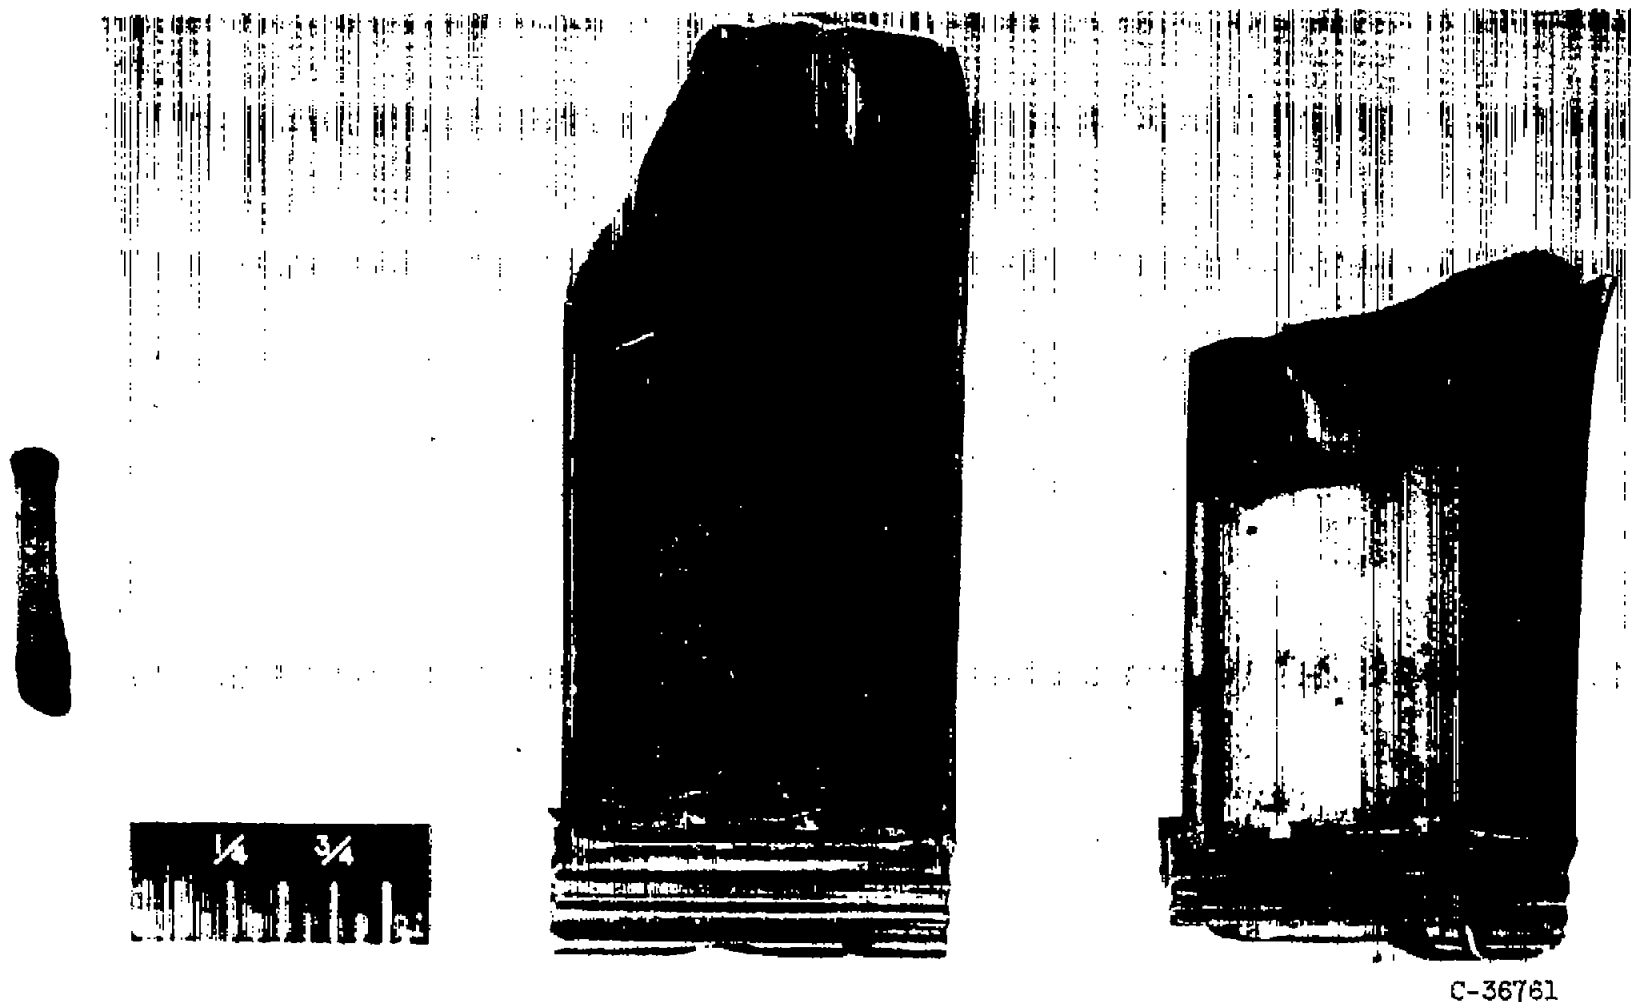
Group 8. - (L-605, 0.030-in. wall, airfoil formed from tubular stock brazed to stub, fig. 3, base A.) Five of the blades tested were undamaged after 30 hours of operation. Seven were withdrawn from the test after sustaining tip failure. Two blades failed near the base, and another blade received excessive impact damage. The majority of the failures originated in the leading or trailing edge, probably as a result of severe bending during fabrication or of inadequate trailing-edge brazing. Two of the failures are shown in figure 15.

Figure 15. - Airfoil failures of Group 8 sheet-metal blades attributed to cracking caused by the forming operation and to imperfect edge brazing.

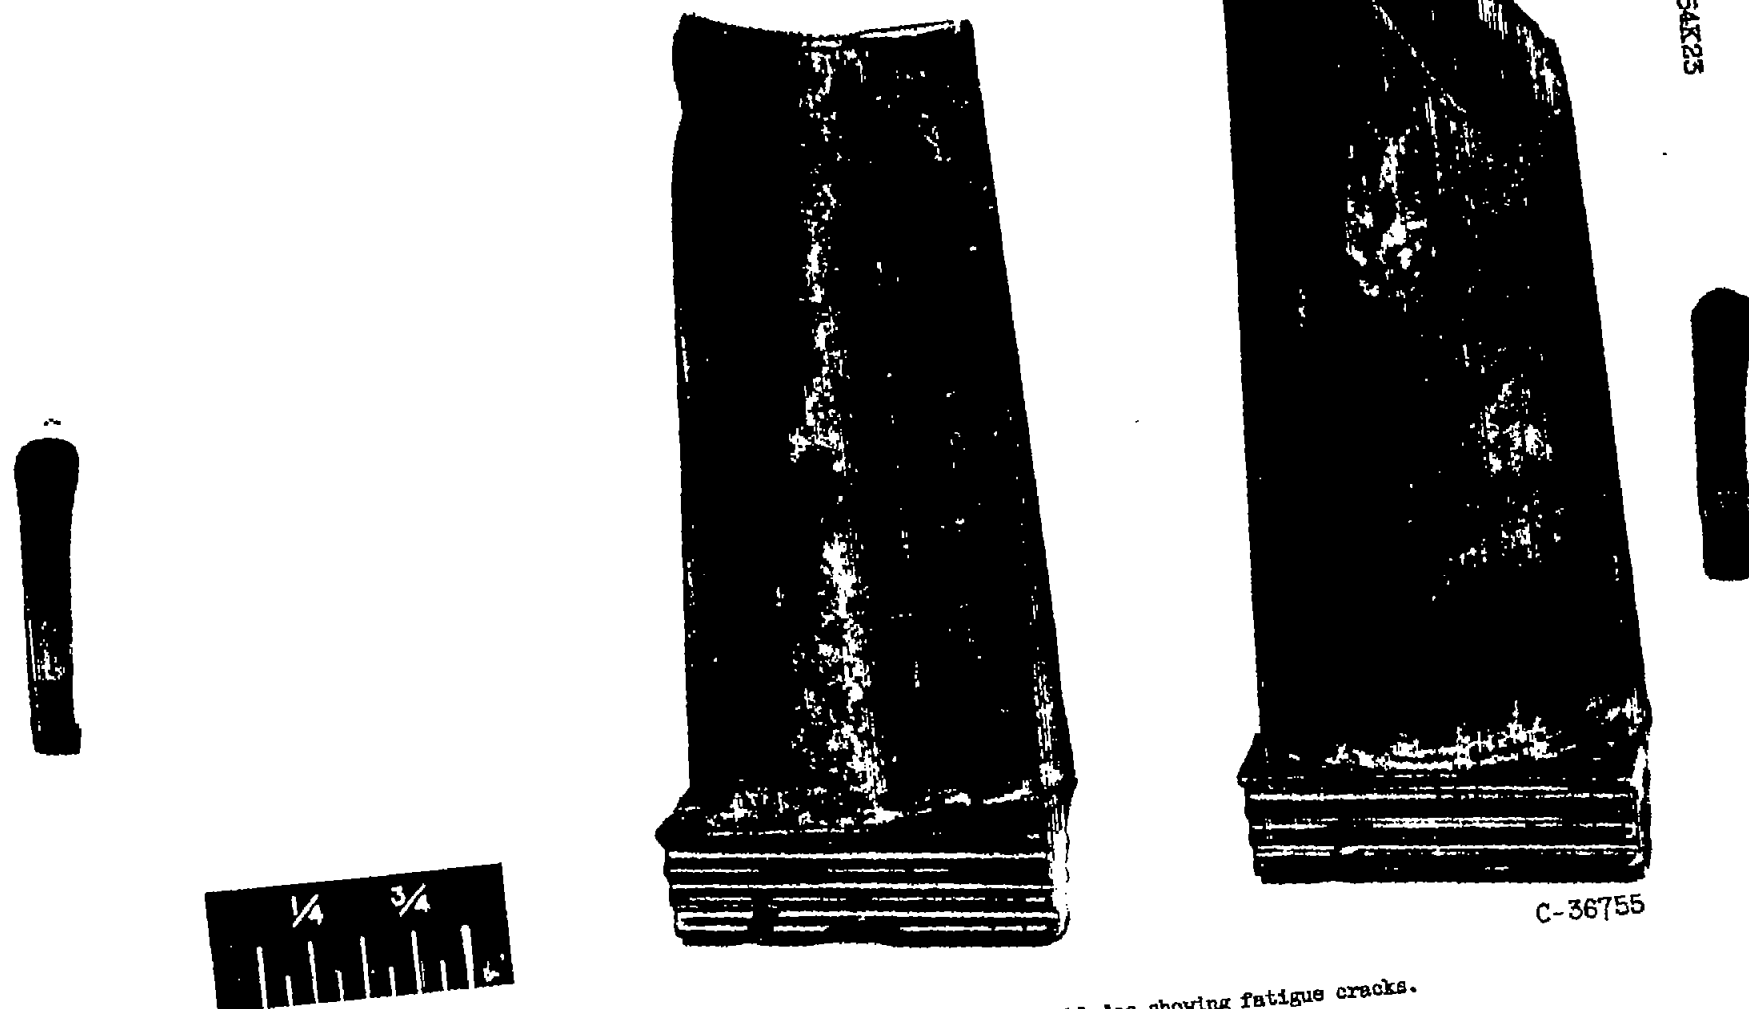
Group 10. - (A-286, 0.030-in. wall, welded airfoil salt-bath brazed to stub, fig. 3, base A.) One blade survived 29 hours of operation before removal from the test because of cracks in the airfoil tip. Three other blades sustained similar failure in shorter operation times. One blade failed in the base as a result of defective brazing. The clearance between parts was correct but the braze material had not filled the joint. The results show that A-286 blades are relatively susceptible to tip fatigue. In addition, it is probable that special welding and brazing techniques are required. The salt-bath brazing was not entirely satisfactory. Figure 16 shows typical failures.

Figure 16. - Tip failure in Group 10 sheet-metal blades showing fatigue cracks.

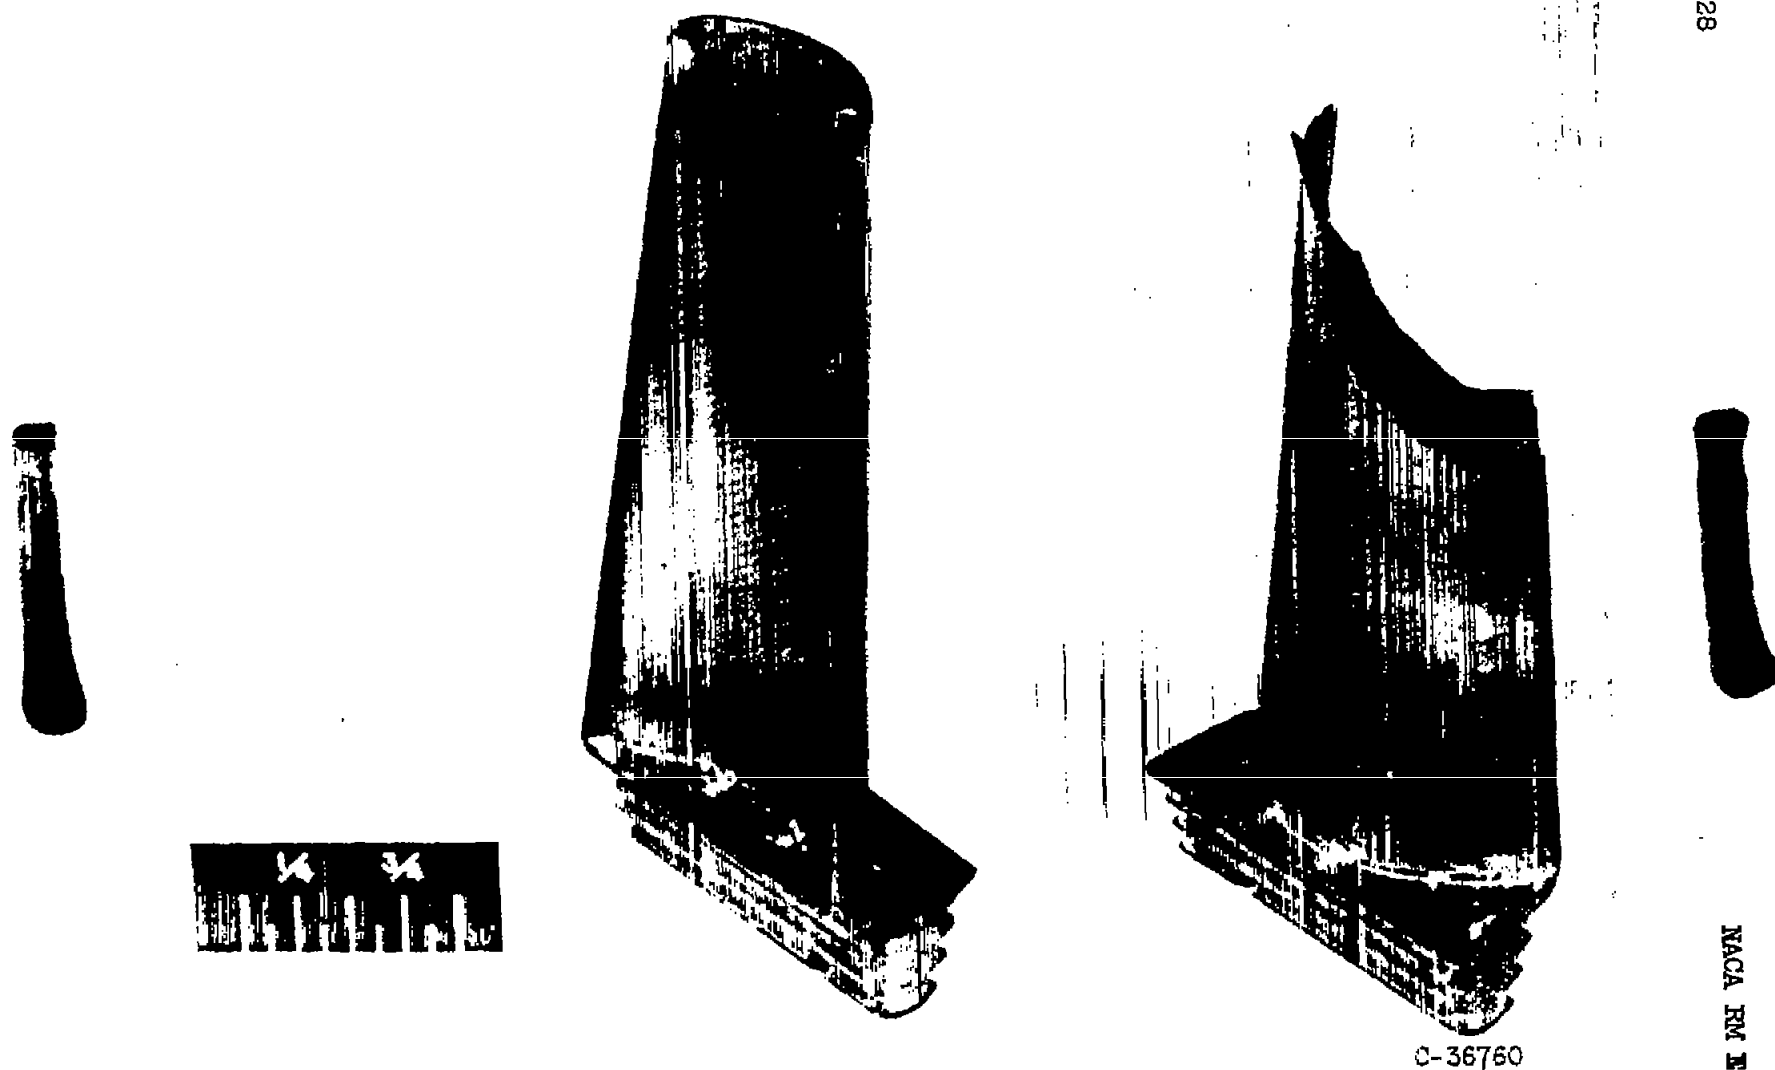
Group 11. - (L-605, 0.030 to 0.020 in. tapered wall, welded airfoil brazed to stub, fig. 3, base A.) Cracking in fatigue after short engine life characterized the failures of the six sample blades. Typical examples are shown in figure 17. The failures occurred at several locations along the airfoil. It appeared that the tapered wall was of insufficient thickness to resist vibration.

Figure 17. - Fatigue failures in Group 11 tapered-wall sheet-metal blades. (0.030-.020-in wall)

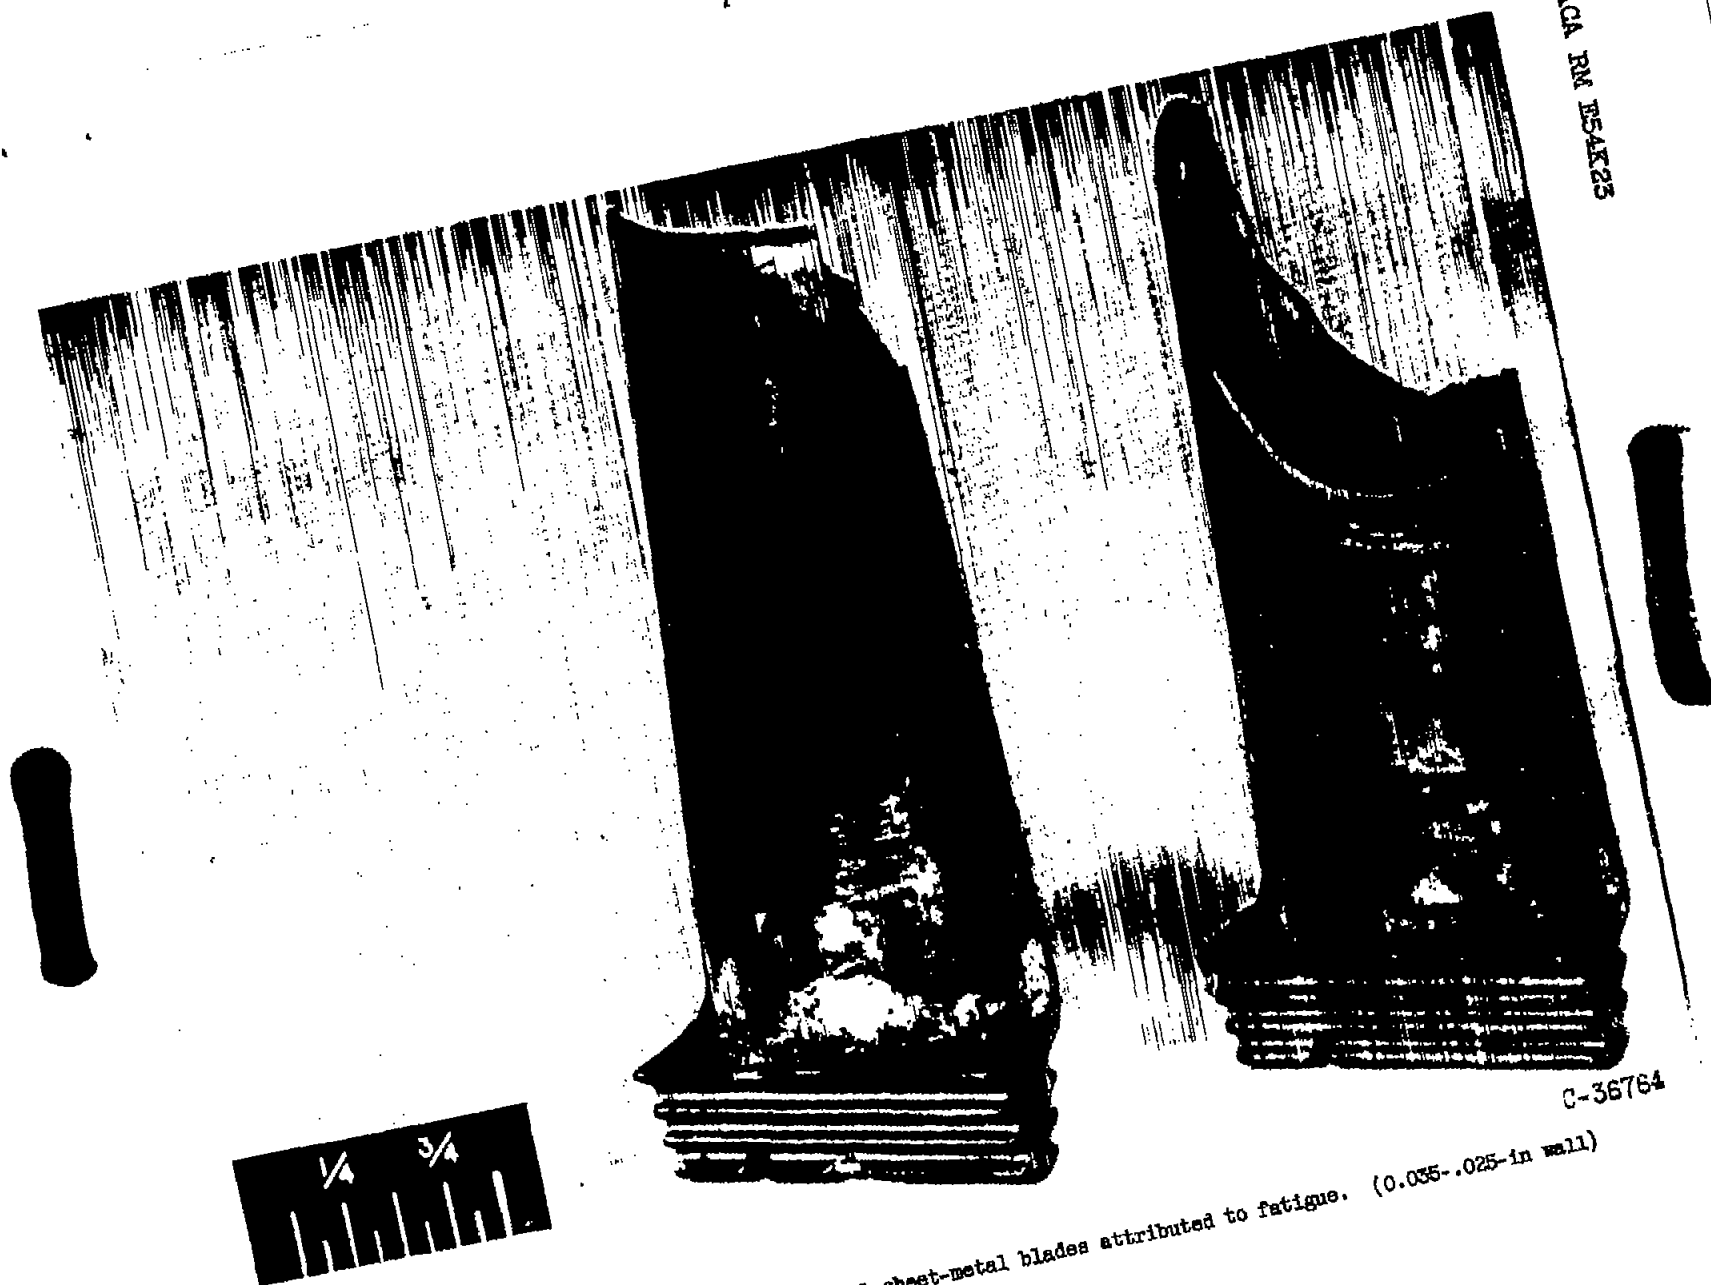
C-36764

Group 12. - (L-605, 0.035 to 0.020 in. tapered wall, welded airfoil brazed to stub, fig. 3, base A.) Three blades of this group failed in less than 10 hours of operation. The failures were all in the tip region, and were attributed to fatigue. It is possible that a welding problem exists where it is necessary to join comparatively thin sheet. On the other hand, slight variations in the machined taper may have been a critical factor. Figure 18 shows the type of failure encountered in

operation. The other three blades were still in good condition at the end of 30 hours in the engine. On the basis of these results it appeared that the wall thickness in the tip is an important factor in a design that employs tapered airfoil walls.

Figure 18. - Failures in Group 12 tapered-wall sheet-metal blades attributed to fatigue. (0.035-.025-in wall)

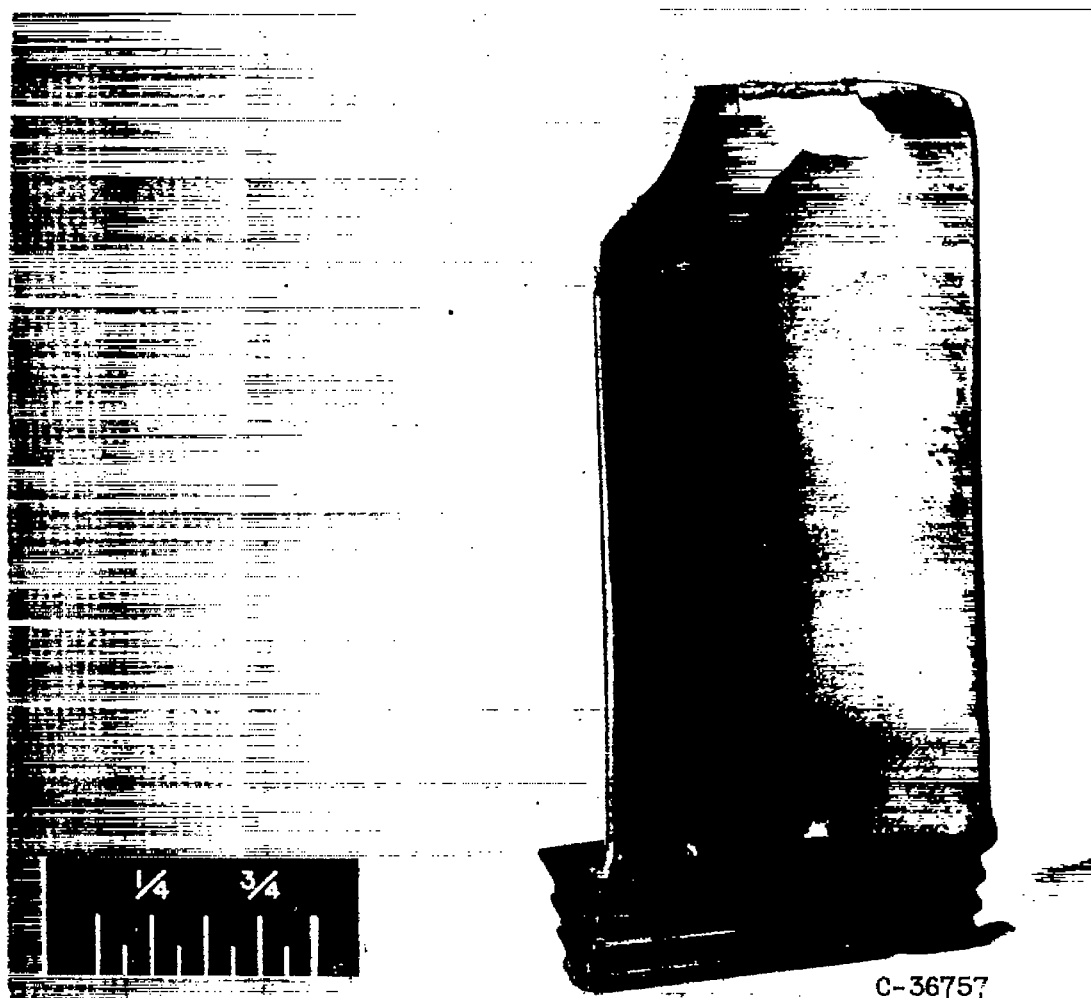
Group 13. - (L-605, 0.040 to 0.020 in. tapered wall, welded airfoil brazed to stub, fig. 3, base A.) There were five blades in this sample group; only one blade failed within the 30-hour test period. This failure occurred in the tip region after more than 29 hours and appears in figure 19. From the appearance of the failure it appeared that the crack originated in the weld. The results indicate that the proper design of tapered airfoil walls may produce satisfactory turbine blades.

Figure 19. - Group 13 tapered-wall sheet-metal blade failure attributed to fatigue.
(0.040-.020-in wall)

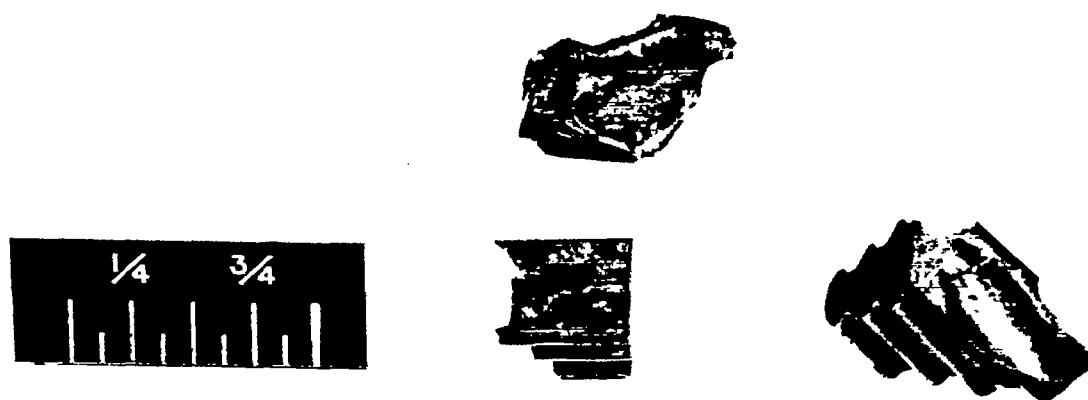
C-36765

Group 15. - (X-40, 0.055 to 0.030 in. tapered wall, cast, modified base.) The six blades of this group were removed after 9 hours. One blade had failed in the root serration and three others showed serious cracking in this region. The two remaining blades had developed cracks in the airfoil as well as in the root. The evidence indicated that the blades of this group were subject to fatigue failure. Figure 20 shows the root-serration failure.

Figure 20. - Root serration failure in a Group 15 hollow X-40 cast blade with a modified root.
